CCN #18	083734 – T	raffic Cras	h Report							
REPORT DATE / TIME DISTRICT / PSA EVENT START DATE			E / TIME - EVENT END DATE / TIME INCIDENT STATISTICS							
May 24, 2018	3 16:51	Second Distri	ct / 203	May 24, 2018	16:11 -					
RESPONDING OFF				WEATHER						
	ZIER (#5617) – M	PD								
ASSISTING OFFICE	ER (ASSIST TYPE)									
TELETYPE DATE / TIME TELETYPE # WHO				WHO NOTIFIED TEL	.ETYPE		REPORTING PERS	ON (FIRST, MIDDLE LAST)		
MAJOR CRASH NO	TIFIED	PERSON NOTIFIED		1		DATE / TIME NOTII	FIED			
	/EHICLES /	NON-MO	TORISTS IN	NVOLVED						
REFERENCE #	NAME / DESCRIPTI					# OF PERSONS (IN	VEHICLE)	VEHICLE TAG # OR PERSON DOB		
v-1	HOND HOND	A CIVIC (AND CR	X)			3				
REFERENCE #	NAME / DESCRIPTI	ON				# OF PERSONS (IN	VEHICLE)	VEHICLE TAG # OR PERSON DOB		
v-2	LINC LINCOLN	N-CONTINENTAL	. MKZ			1				
REFERENCE #	NAME / DESCRIPTI					# OF PERSONS (IN	VEHICLE)	VEHICLE TAG # OR PERSON DOB		
v-3	VOLK VOLKSV	VAGEN JETTA				1

Crash Diagram		
CCN#	EVENT START TIME / DATE – EVENT END DATE / TIME	WEATHER
18083734	May 24, 2018 16:11 -

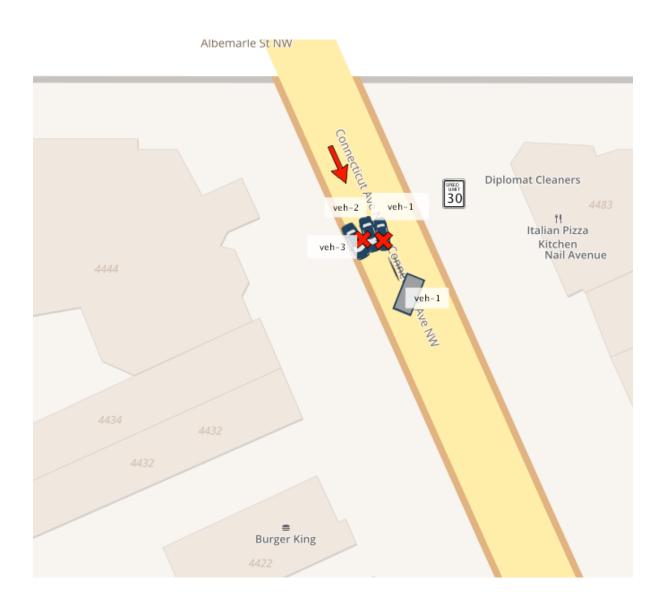
The accident occurred in the 4400 blk of Conn. Ave NW D-1 states that as she was driving S/B in the 4400 blk D-2 pulled into her lane which caused her to change lanes quickly and cause her to over correct the vehicle which then cause a roll over. D-2 states that as he was driving in the 4400 blk of Conn. Ave NW D-1 came into his lane striking his vehicle and then lost control and rolled over and came to a rest in the 4400 blk of Conn. Ave NW. D-3 states that as she was parked in the block she didn't see the accident, she felt V-2 strike her vehicle. Due to conflicting stories and possible video from the flagship car wash this investigation is still pending. All passengers in Veh-1 where released from WHC and Sibley. Sgt. Tran took 53 photos of the scene and up loaded them to evidence.com. BWC activated. The witnesses were not on the scene to be interviewed by the reporting officer.
